Manhole Inspection Summary

Manhole # S15KK1006MH

Insp Date: **12/5/06 1:21 PM**

Location Address: **4538 FINNEY AVE**

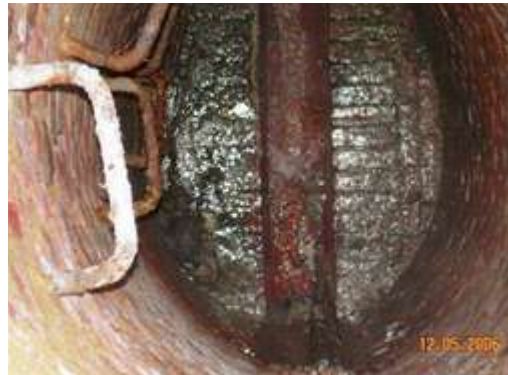
Top View

Corroded steps. Bench debris.

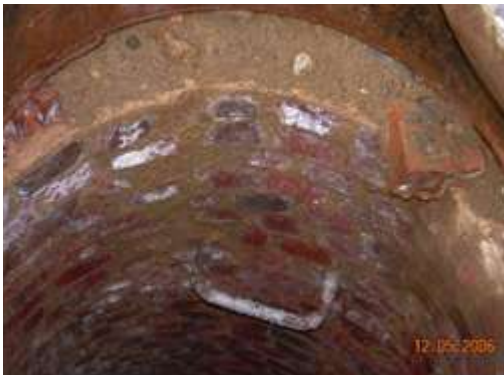
Defect

Frame leaks. Frame offset. Adjustment loose brick, deterioration, and infiltration.

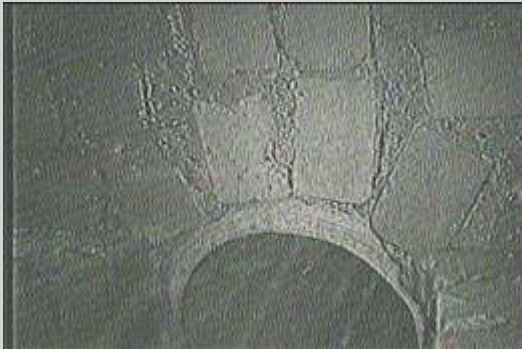
8 in. Circular Gravity Sewer Pipe Out @ 12 O'Clock

Infiltration: **Evidence** Pipe Seal Cond: **Cracked**

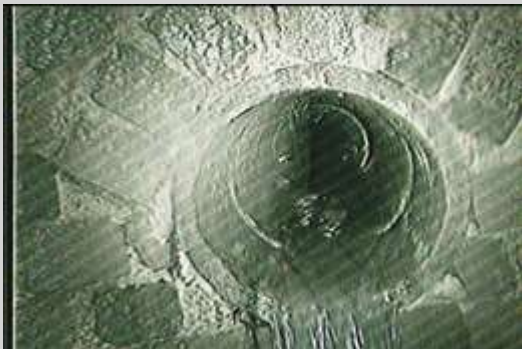
8 in. Circular Gravity Sewer Pipe In @ 6 O'Clock

Infiltration: **None** Pipe Seal Cond: **Cracked**

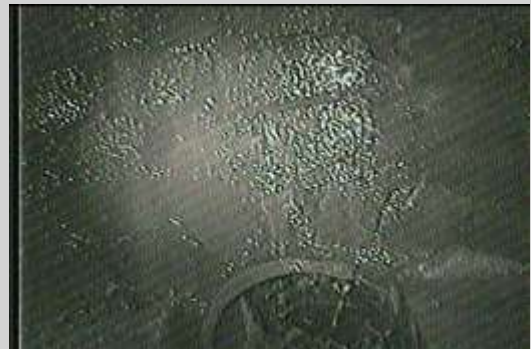
Drop In @ 6 O'Clock

Drop Condition: **Clogged**
